## APPENDIX A

### **Extending the Life of Sinking Groundline: Observations and Experiments**

**Prepared by Richard Allen**

**May 2012**

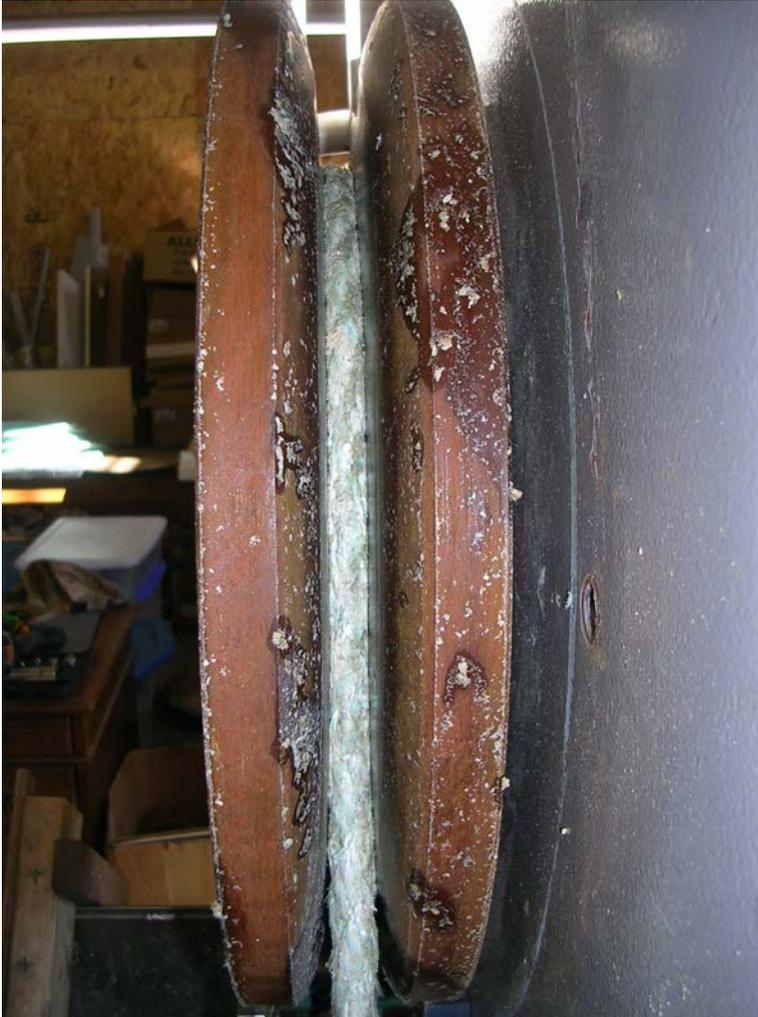
**Figure 1** Lobster trap haulers work by wedging the pot warp between two steel discs. Higher tension in the line causes it to wedge more deeply into the V between the discs.

Lobster trap haulers are so simple that it is easy to assume that they aren't part of the rope wear problem and they can't really be improved much. It may be helpful to think about how they do their magic. The sheaves develop tension in the groundline through friction and the wedging action of the V shape shown in Figure 1. It's important to keep in mind that the squeezing, or wedging action creates considerable sideways pressure on the rope, in addition to the lengthwise strain of the pulling action. Pressure from the hauler and flexing over pulleys caused flattening of the filaments of polyester (PET) yarns, and, splitting, flattening and compression of the polypropylene (PP) yarns as seen under microscopic analysis of used groundlines. The rope also slides across the surface of the sheaves as the rope passes around them, causing fiber abrasion on the surface of the rope.

This “grating” action is especially noticeable with machined-steel sheaves hauling rope with a heavy strain. Contrary to its relatively smooth appearance to the naked eye, a machined steel surface looks like a mountain range under a microscope. Rope dust comparable to sawdust could be seen being scraped off groundlines during machine testing using machined-steel hauler discs.

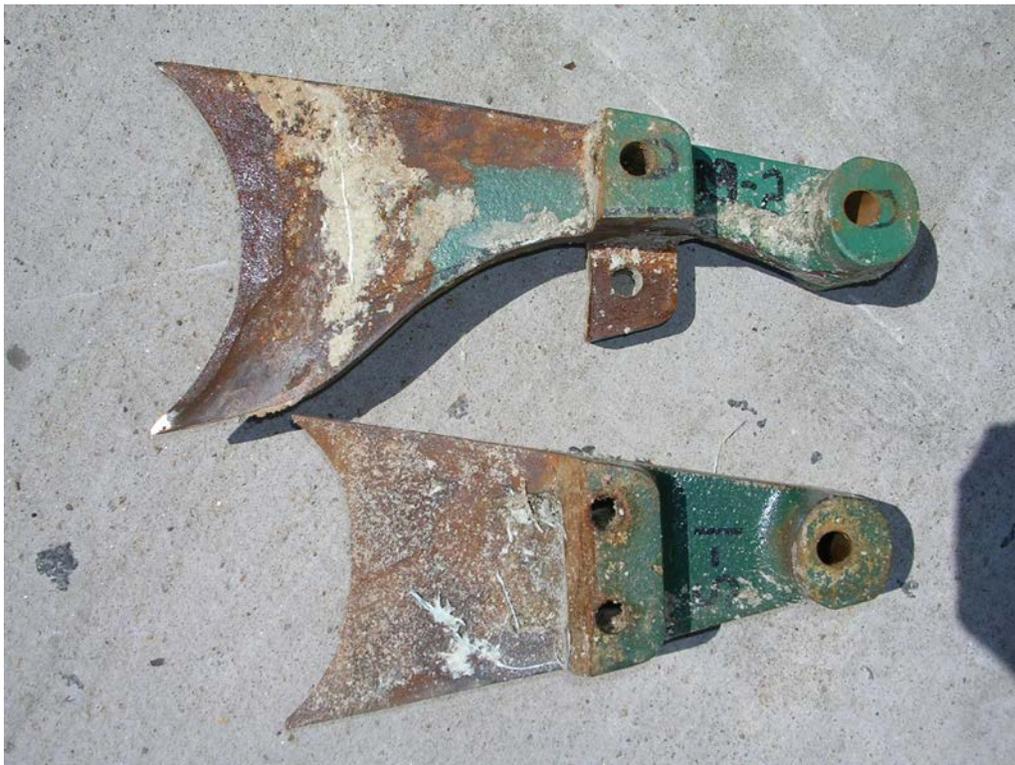
**Figure 2 – A splitter with a reverse curve (top) lifts the groundline out of the hauler gradually in comparison to a straight-sided splitter (bottom).**

Experiments with the hauling machine also showed an improvement in rope longevity through the use of a splitter with a reverse curve on the edge that meets the rope (Figure 2). The reverse curve reduces the angle at which the rope impinges on the splitter, thus lifting the rope out of the V more easily. Splitter load cell readings with the reverse curve splitter were significantly lower than with the standard splitter. The reverse curve splitter may not be practical on smaller haulers, another reason for using the largest hauler possible.

Lobstermen will be sticking with the standard trap hauler for the foreseeable future, making it important to use the most rope-friendly splitter design. The reverse-curve splitter proved to reduce rope wear in laboratory tests and has been used with success in the field.
