Project 2 Final Report

Review of Sinking Groundline Performance in the Maine Lobster Fishery, with Recommendations for Improving its Fishability

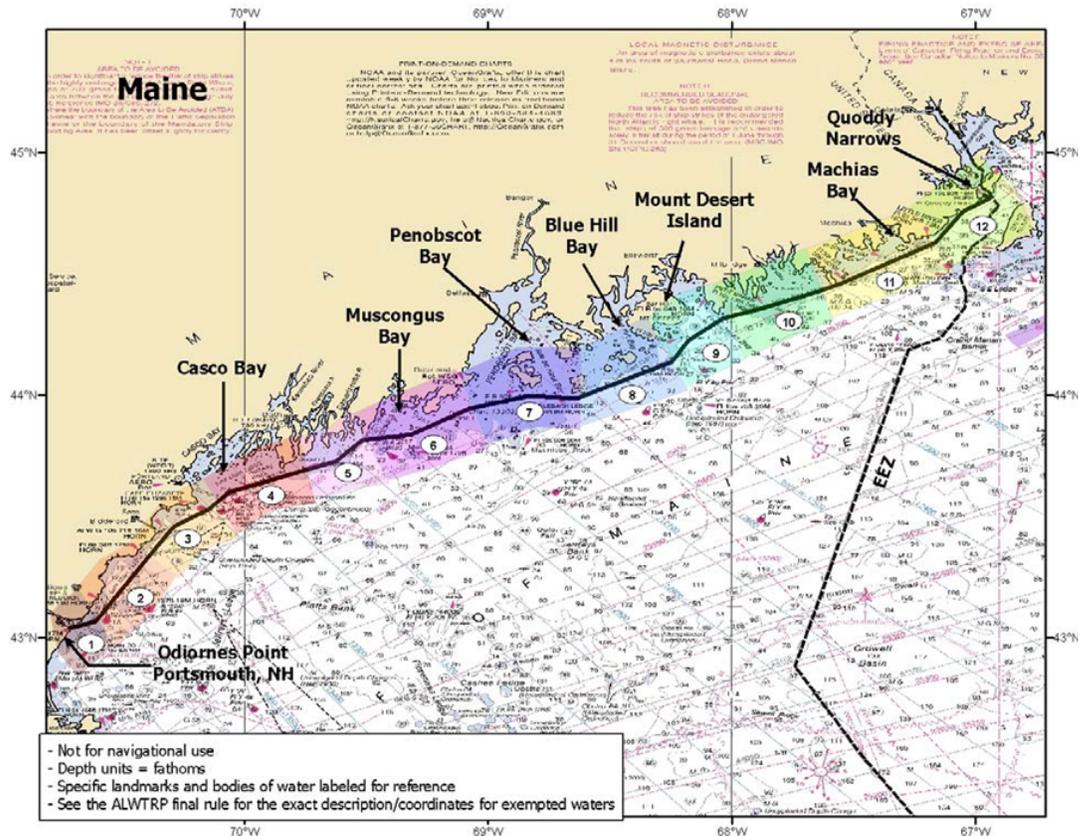
Figure 1. Maine Whale Rule Exemption Line – Chart depicting the nearshore exempted area for Maine, outside which sinking groundlines must be used. Detailed charts available through the Atlantic Large Whale Take Reduction Plan: Outreach Supplement to the Maine Exemption Line at www.nero.noaa.gov/whaletrp/plan/outreachsup.html.

2007). The exemption line established along the Maine coast allows floating groundlines to be fished in 70% of state waters. In its 2007 Final Environmental Impact Statement (FEIS) NMFS concluded “right whales are unlikely to spend substantial amounts of time in the coastal waters of Maine” and that adopting the exemption line “would provide an adequate level of protection to endangered large whales.” (NMFS 2007 FEIS, page 3A-9; <http://www.greateratlantic.fisheries.noaa.gov/whaletrp/eis/>) (Figure 1).

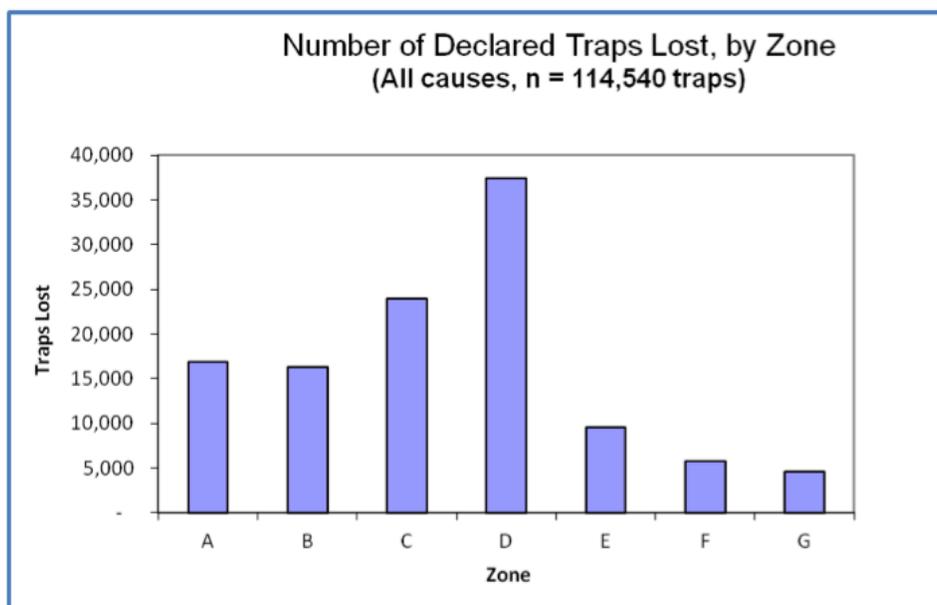
Figure 2. Number of declared traps lost by zone (2009-2011).

GOMLF and MLA reviewed the affidavits completed by lobstermen over a three-year period, from 2009 to 2011, to investigate the number of traps reported as lost. More than 26,000 traps were reported lost due to sinking groundline, second only to boat traffic, which claimed more than 50,000 traps. With an average rigged trap costing \$100, assuming that sinking groundline explained the 26,000 traps lost, Maine lobstermen had \$2.6 million in trap replacement costs as a result of using sinking groundline over that three-year period. That does not include income lost while the trap is being replaced and not catching lobsters. The most significant sinking groundline losses were reported in Maine's eastern and mid-coast areas, in Zones A through D. Figures 2-4 provide a summary of the results.

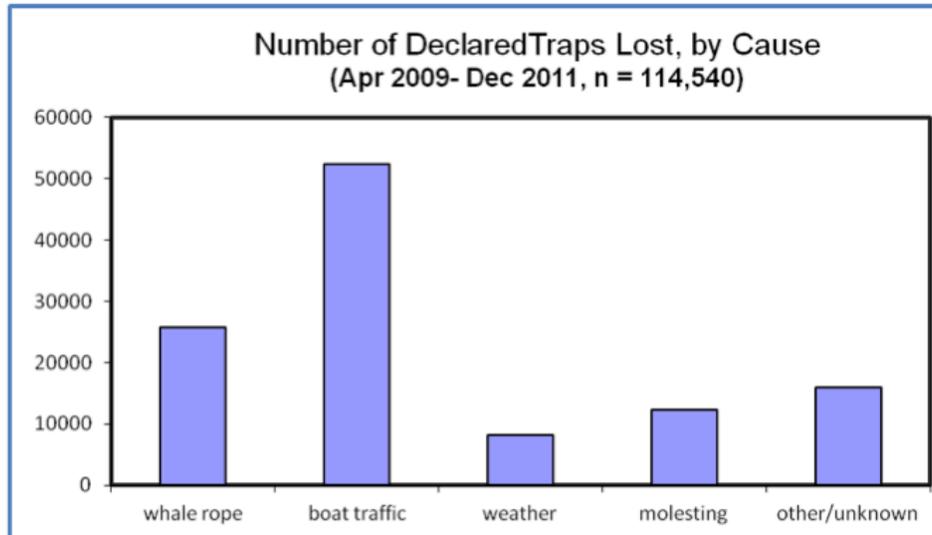
Figure 3. Declared traps lost by cause. Trap loss was ascribed primarily to four main causes.

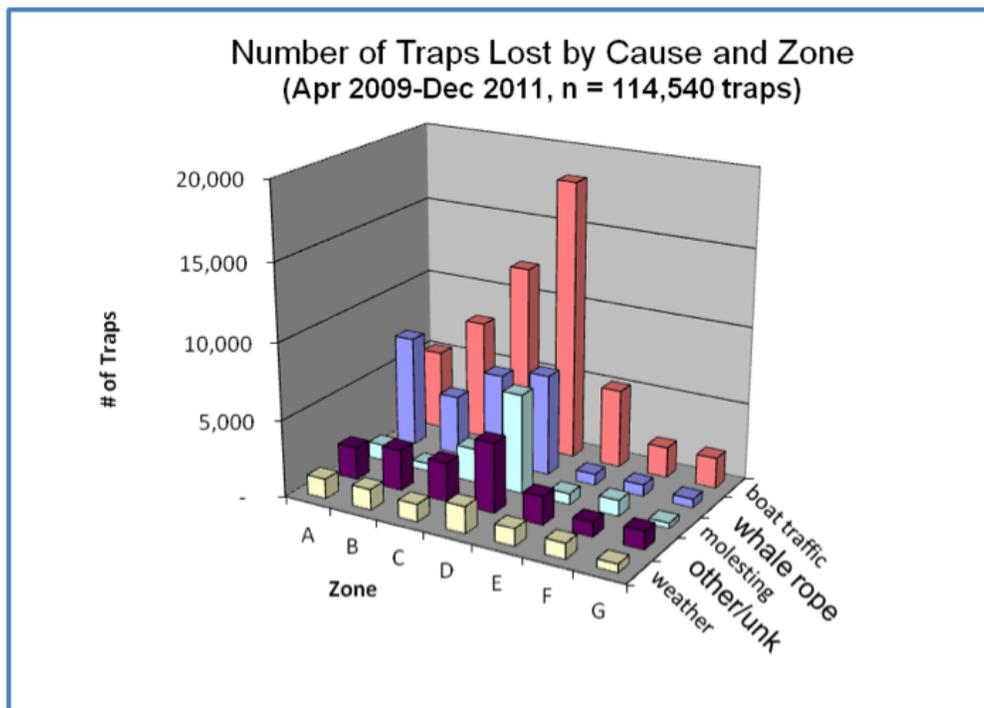
Figure 4. Traps lost by cause and zone. Sinking groundline was reported as the leading cause of lost traps in Zone A, consistent with where lobstermen report the most challenging conditions of using sinking groundline.

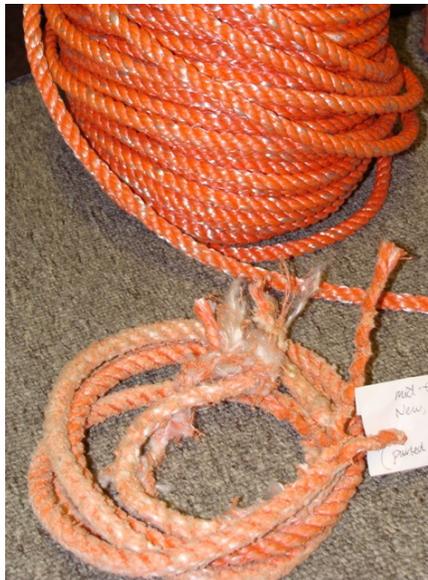
Figure 5. A portion of sinking groundline that parted after only three hauls, compared to new rope behind it. (Photo L. Ludwig)

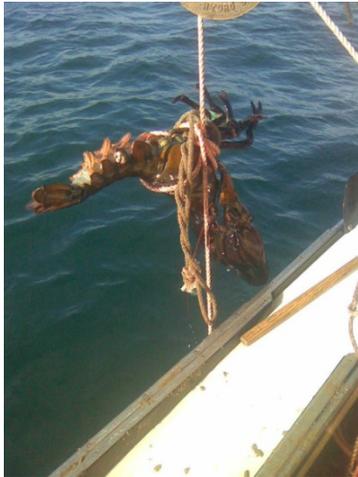
Figure 6. Lobster caught in sinking groundline. (Photo B. Fernald)

Issues reported by lobstermen when using sinking groundline include poor handling on deck; tension during hauling due to hanging down; limited to no stretch or flexibility under tension leading to snapped lines and dangerous boat handling conditions; intense noise when run through the hauler; weakened sections of line due to chafing on bottom; and more difficulty in predicting when the rope is nearing the end of its operational life. Many lobstermen have documented their experiences by taking photos that show situations atypical when using floating groundline. One of the most unusual experiences occurred when a lobstermen from Little Cranberry Island entangled a 20-lb lobster between the 2nd and 3rd trap of a triple (Figure 6), remarking that sinking groundline “does everything you don’t want it to do.” Other examples include snared boulders, bent davit arms, and wrapped traps (Figures 7-9).

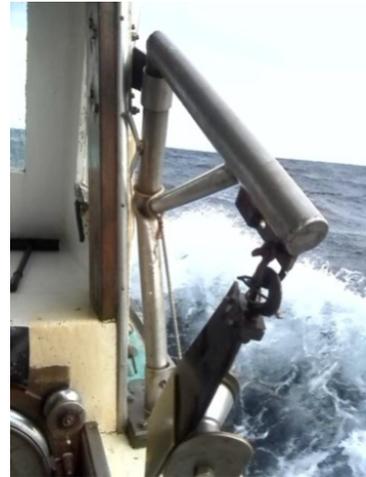
Figure 7. Bent davit. (Photo C. Moore)

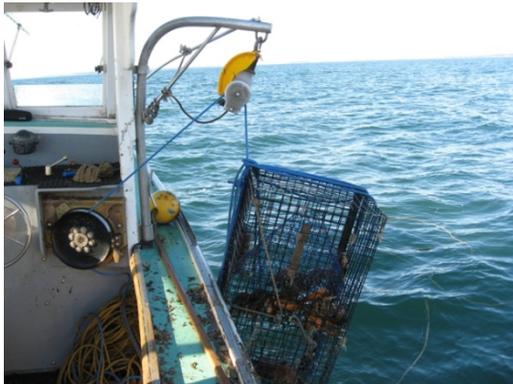
Figure 8. Lobster trap wrapped in sinking line. (Photo J. Alley)

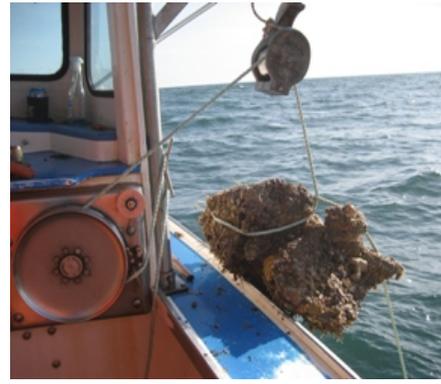
Figure 9. Boulder wrapped in sinking line. (Photo J. Alley)

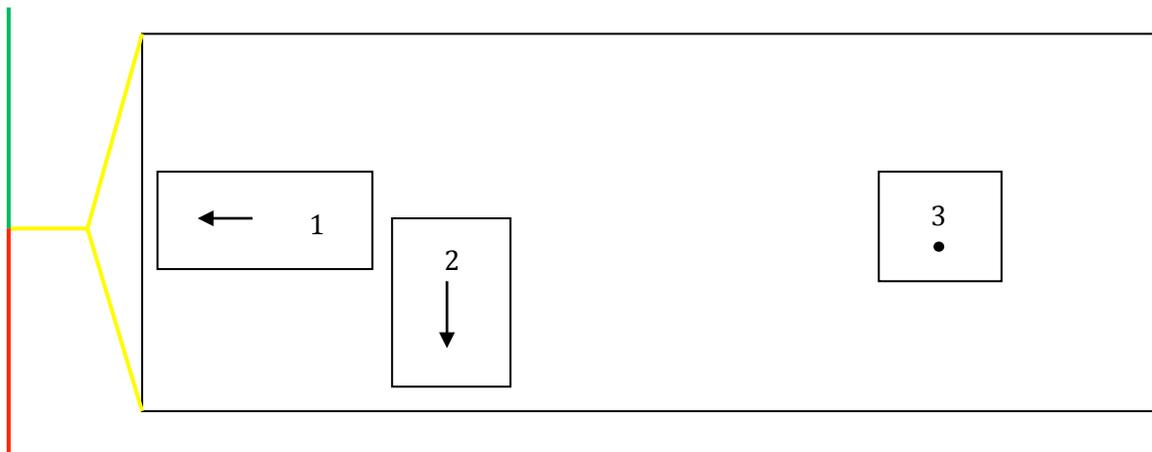
Figure 12. *Experimental trap, as seen from above. Arrows indicate direction of camera lens. Camera 1 was positioned to look out at the groundline, Camera 2 looked out the side of the trap, and Camera 3 was positioned to shoot upwards for capturing vertical line movement. The bridle and gangion are shown in yellow and the groundline is in red. The vertical line is in green. In areas of Downeast Maine where anchors are fished, the anchor is tied in at the end of the vertical line, just before the gangion.*

The configuration of the cameras inside the trap is shown in Figures 12 and 13. The front camera was positioned to observe the groundline, the side camera was placed to capture any potential movement of the groundline back towards the trap based on lobstermen's accounts of lobster traps being hauled up wrapped in sinking rope, and the top camera oriented to observe any potential interaction between the vertical line and the groundline since the two ropes connect together at the gangion. The trap entries for lobster were covered so that the trap was not fishable. Additional bricks were added to the trap to counteract the buoyancy of the underwater housing cases.

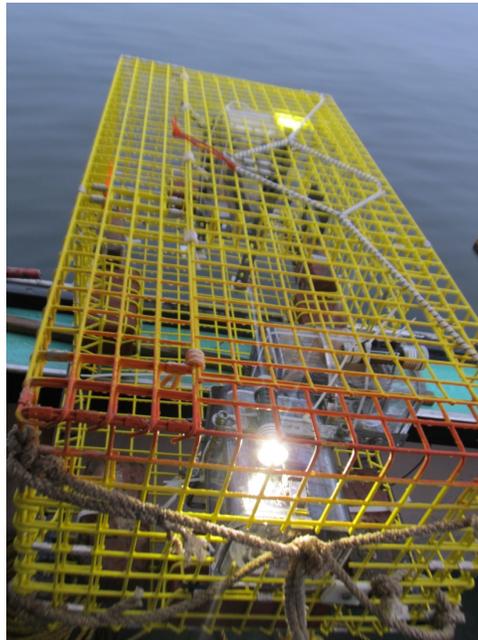
Figure 13. *The experimental trap with three cameras mounted inside and additional lighting.*

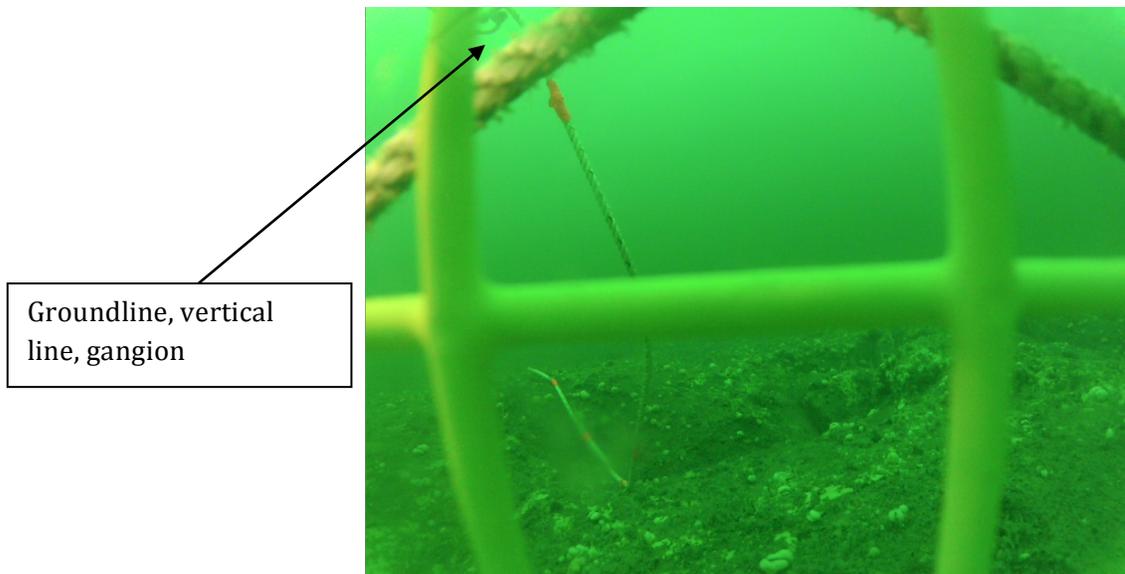
Figure 14. Still image from the front-facing camera (at 63 min) showing the groundline with orange markings and the groundline, vertical line, and gangion tie-in in the upper left.

Testing was again carried out near Biddeford Pool in water 94 feet deep with a rocky bottom. The gear configuration remained the same as on the previous day. The quality of the video shot by the front camera was fair to excellent, and the groundline was visible throughout the 4 hr and 53 min duration of video recorded. The camera recorded video showing the intersection where the gangion, groundline and vertical line are tied together (Figure 14).

From the tie-in, at least six markers can be seen on the groundline during the video. The groundline can be seen laying on the substrate between markers five and six (or six feet from the gangion and vertical line). The bottom section of the vertical line

was *Manline* floating rope, which appears to be elevating part of the groundline. Throughout the video, the groundline moves back and forth in front of the camera and is pulled up and down by the vertical line. That movement causes the groundline to rub against the substrate at the point where it first encounters the bottom. The remainder of the groundline is slack, but remains primarily stationary, with some slight movement towards the trap. The side and top cameras did not provide any additional information.

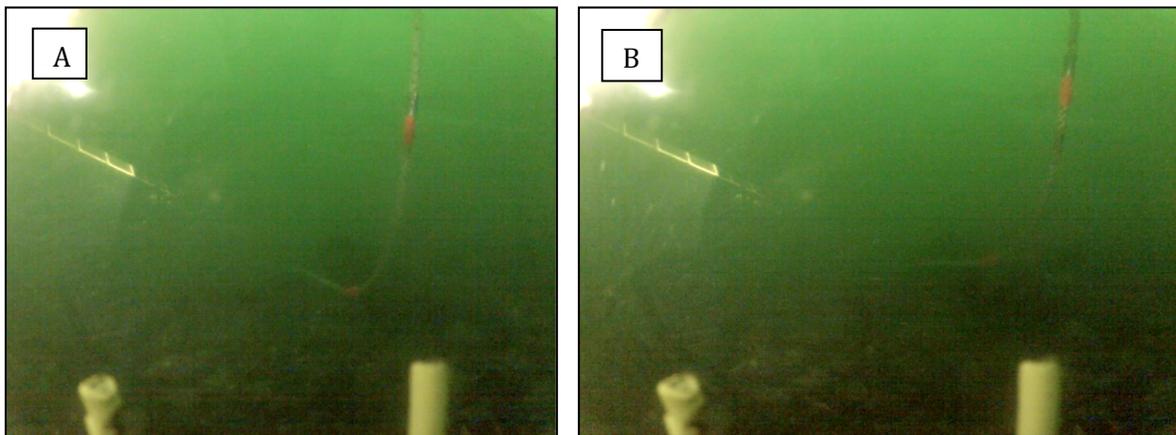
Figure 15. *Two screen captures of groundline movement. The line moves from the ground in A to the right and up in B.*

The experimental trap was deployed out of Biddeford Pool during rain, 20-knot winds, and seas up to 6 feet. The gear was deployed onto a mud/sand bottom in 55 feet of water. The experimental trap was the lead trap in a three-trap trawl with 100 feet of vertical line. The quality of the video from the front and side was very poor, possibly due to the weather and loose sediment on the bottom, and for an undetermined reason the top camera did not record any feed that day. The groundline was visible in the right side of the video recorded by the front-facing camera, and up to four markers were visible on the line. The groundline makes contact with the bottom between the fourth and fifth markers, and is shown being pulled up and down by the vertical line and side-to-side, most likely due to the movement of bottom currents or tide. The extent of line movement is pictured in Figure 15.

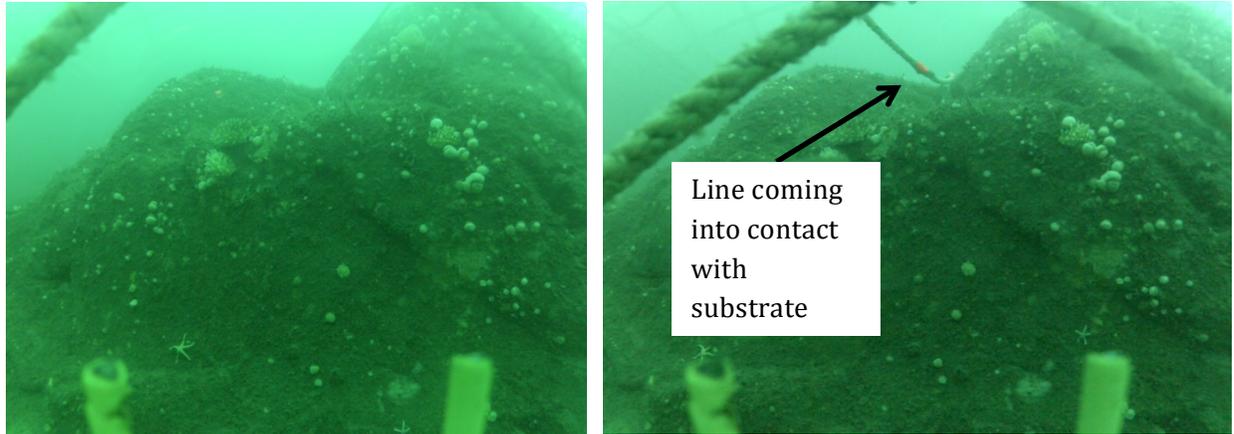
Figure 16. A) *The groundline rubbing against the boulder on the right side of the image.* B) *Groundline moved significantly toward the middle and the line slack has increased.*

A three-trap trawl was deployed on a sunny day in 13 feet of water on rocky bottom. Two hundred feet of vertical line was used and 60 feet of groundline separated the traps. All of the video on this day was excellent. The front video shows the groundline laying over a large boulder and moving back and forth. There is significant movement of the groundline over the boulder (Figure 16). The vertical

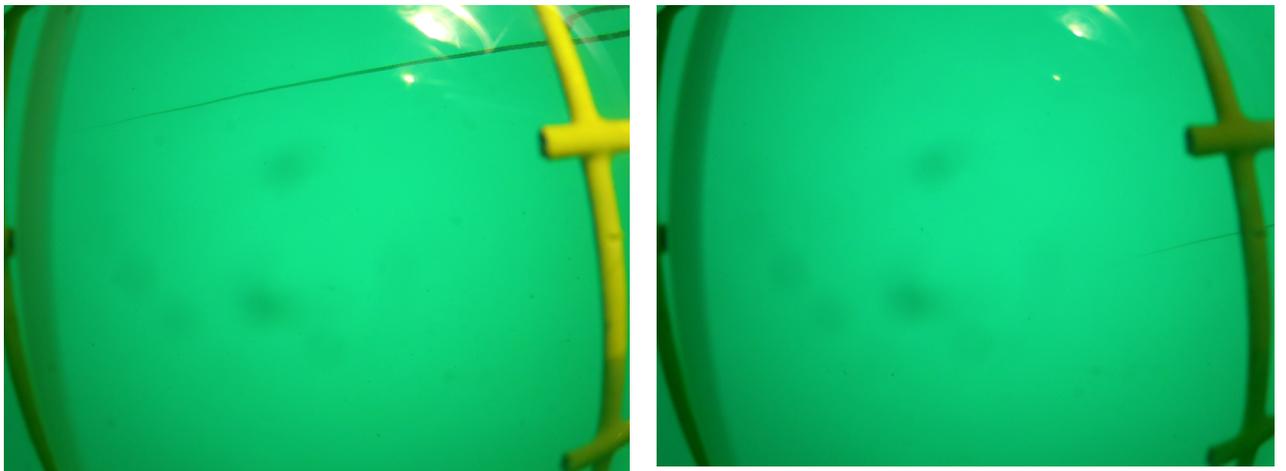
Figure 17. *The vertical line as recorded by the top camera.*

line can also be seen in the Top camera video. It frequently moved in and out of the video frame (Figure 17).

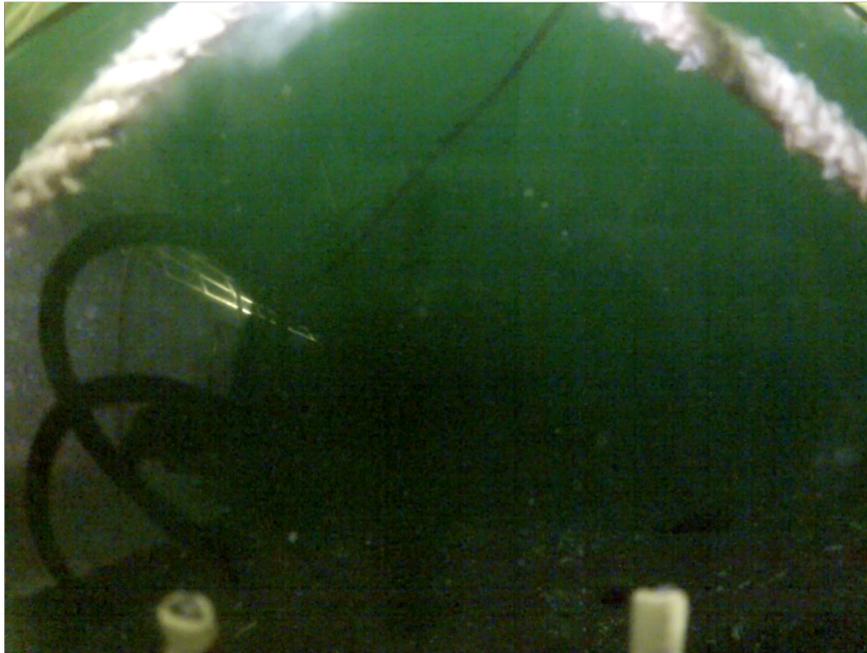
Figure 18. *Best image obtained of the groundline from the front-facing video camera. No contact with the ground can be seen due to the image quality. The dark lines are shadows from the battery extension cords connected to the camera.*

The experimental trap was deployed out of Cushing, mid-coast of Maine at a depth of 108 feet, and on a bottom consisting of gravel, rock, and cobble (as reported by the captain, although the video shows a lot of sand and mud). The experimental trap was the lead trap in a double, attached to a 132ft vertical line. The weather was a mixture of fog, rain, with 5- to 10-knot winds. The seas were reported to be two to three feet. All of the video from this day was of poor quality. The groundline was visible in the video shot with the front-facing camera, but the interaction between the line and the ground cannot be seen (Figure 18). Nevertheless, it was possible to observe a lot of movement of the portion of the groundline nearest to the trap in multiple directions (vertically in the water column, as well as side to side). This high degree of movement and contact with the substrate would cause chafing.
